# **Qualitative Assessment for the Pete King Project Area Streams Using Proper Functioning Condition Approach (PFC) 2019**

## **Introduction**

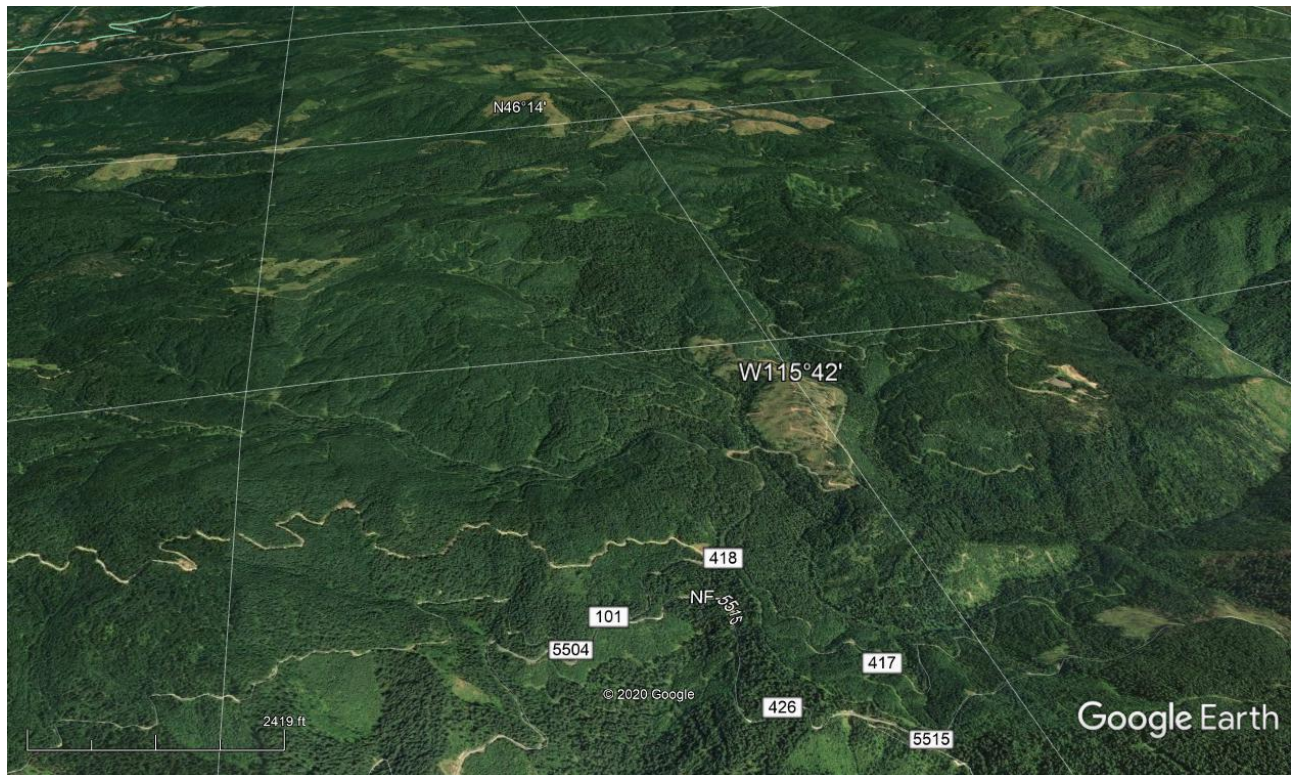
**Pete King Assessed Reach 6 (~18000ft):** Large woody debris (LWD) is an integral part of this type of stream system. LWD dissipates erosive energy, controls bedload transport, stabilizes stream channels, and creates suitable habitat for fish and other aquatic organisms. The stream channel is shaded by a dense overstory of mature cedar and fir trees that also provide LWD recruitment. Moss on in stream wood and rocks indicate moderate to low erosive stream hydrology. In summary this stream channel reach, adjacent to the project area and therefore most subject to effects should, given the RHCA buffers, remain in a stabilized condition and should continue to improve in complexity and stability over time and trend toward desired conditions for aquatic habitat as existing fine sediments move out of the system and minimal fines are input. The fish habitat suitability (pools, complexity, clean water and shade) in this reach should be maintained or improved over time given the protective riparian buffers which will remain intact.

This reach is rated as **Proper Function Condition (PFC)**

Photo 24: Pete King Creek Assessment Reach 6 (46°11'23.53"N 115°40'04.83" W)

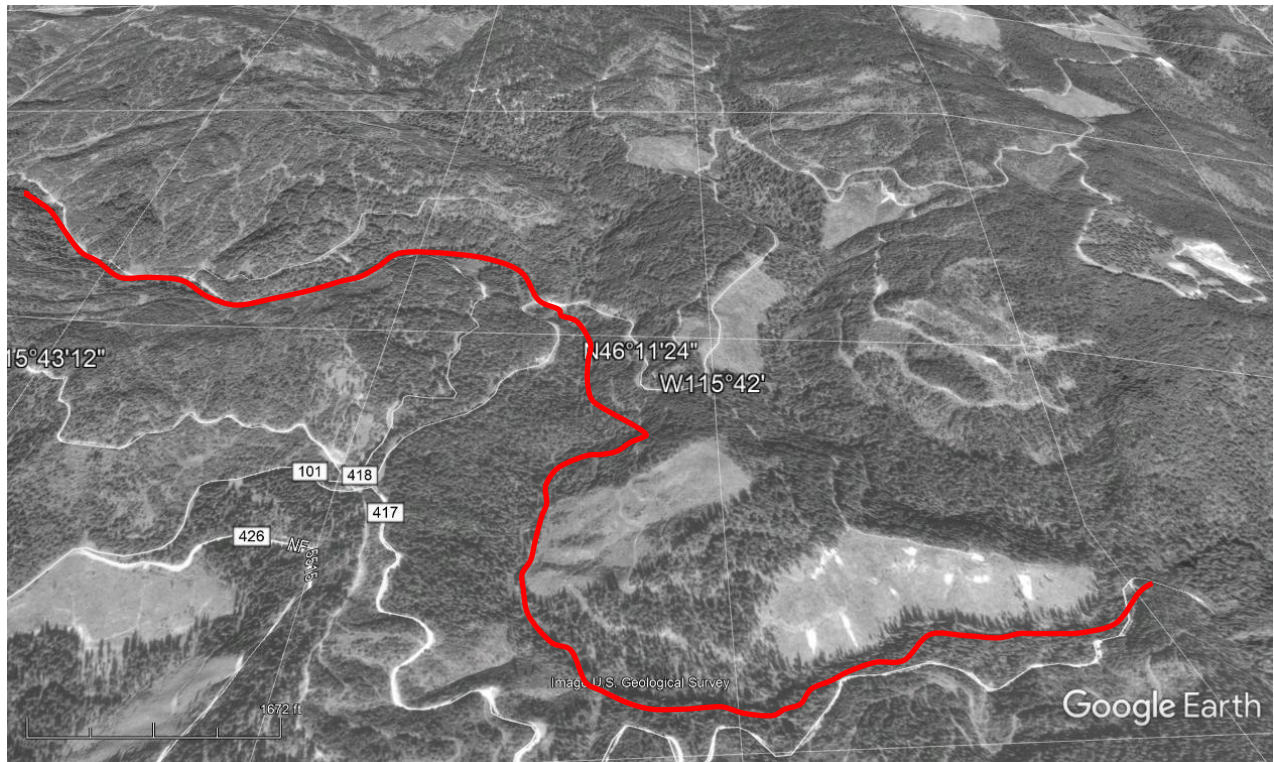
Photo 25: Pete King Creek Assessment Reach 6 mid 1990s Photo. Showing very little change in channels over time indicating stability and upward trend considering greater abundance of stream side vegetation today (compare photo 2 and 3) and less gravel bars indicating less bedload movement.

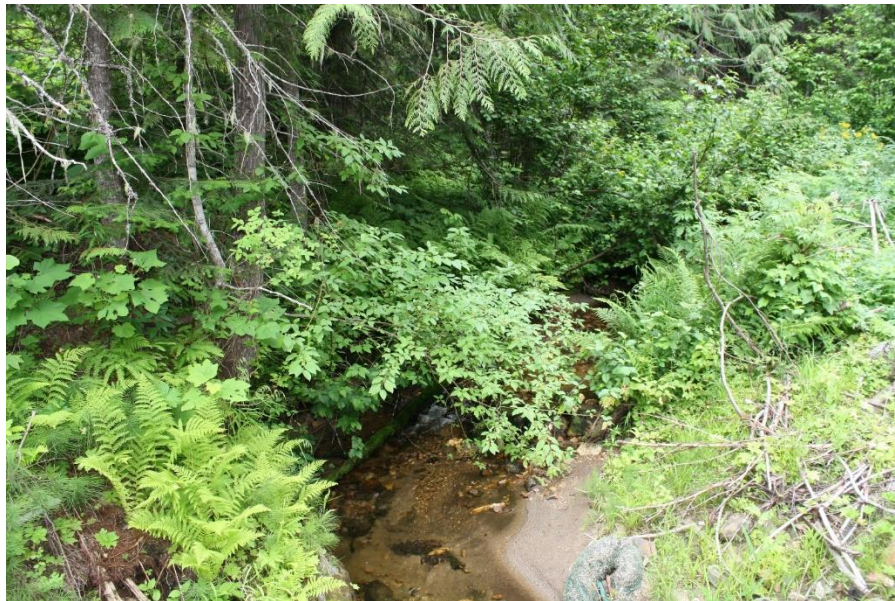
Photo 26 Reach 6: Pete King showing heavy vegetation on stream banks for stability and shade. Channel stability and resiliency to high flow events is high.

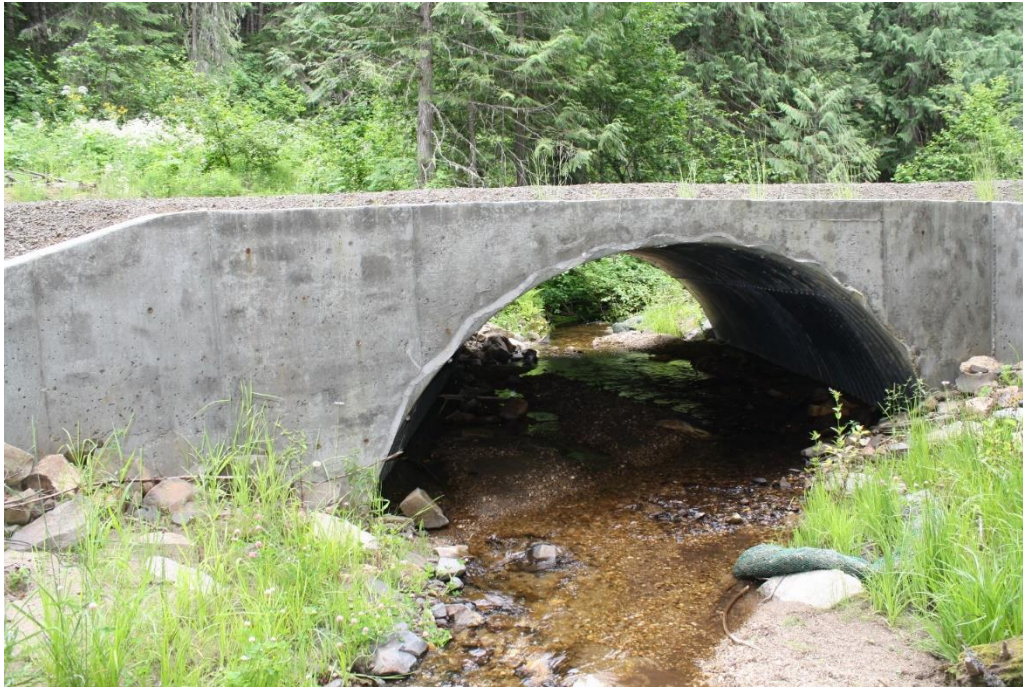
Photo 27 Reach 6: Stable and functioning road stream crossing. Recently constructed AOP crossing. Grasses on gravel bars indicate stable flows and high riparian function.

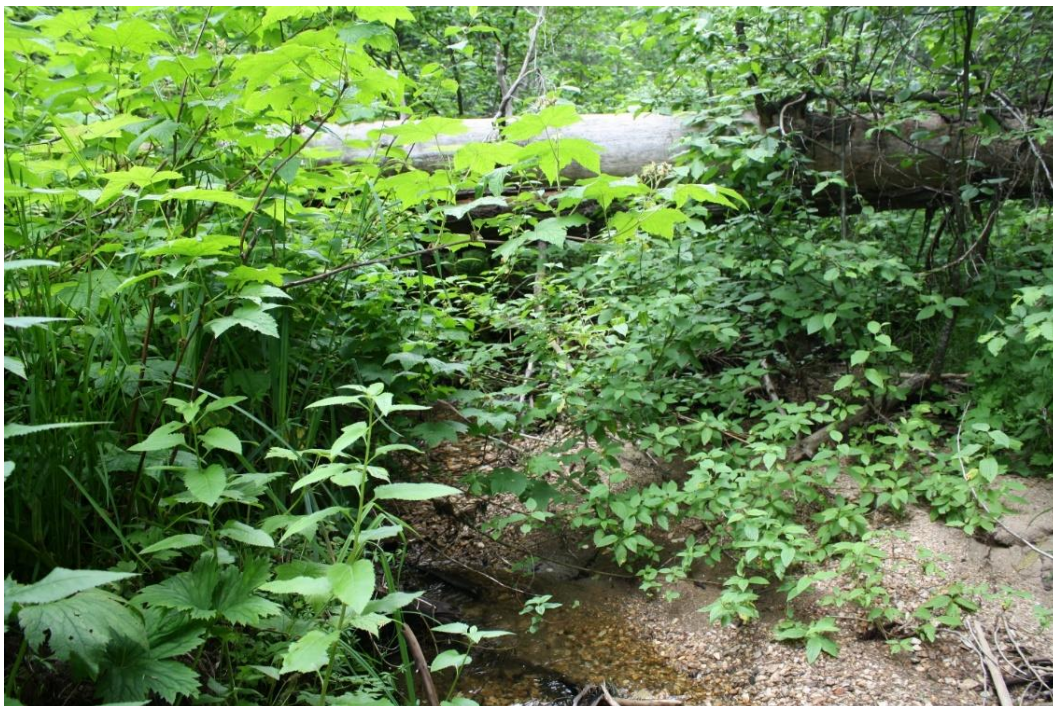
Photo 28 Reach 6: Pete King showing heavy vegetation on stream banks for stability and shade. Channel stability and resiliency to high flow events is high. LWD plays key role in stability and habitat formation.

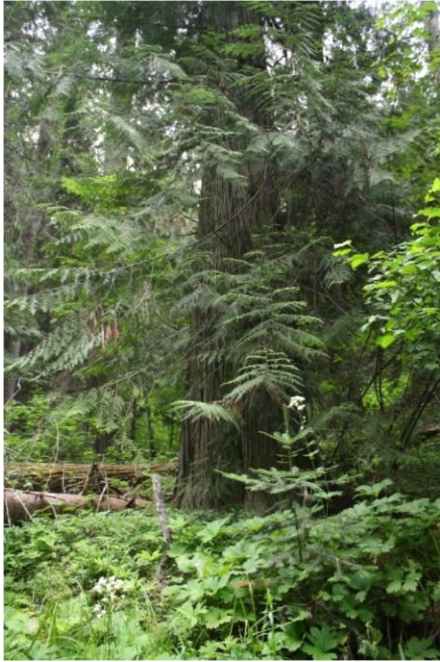
Photo 29 Reach 6: Pete King showing heavy vegetation on stream banks for stability and shade. High level of riparian LWD equipment with multi age class conifers.

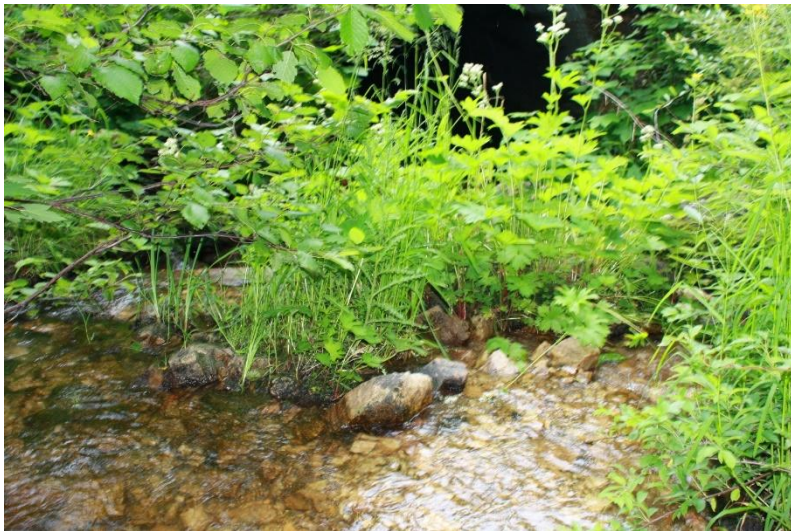
Photo 30 Reach 6: Stable and functioning road stream crossing. Grasses on gravel bars indicate stable flows and high riparian function.

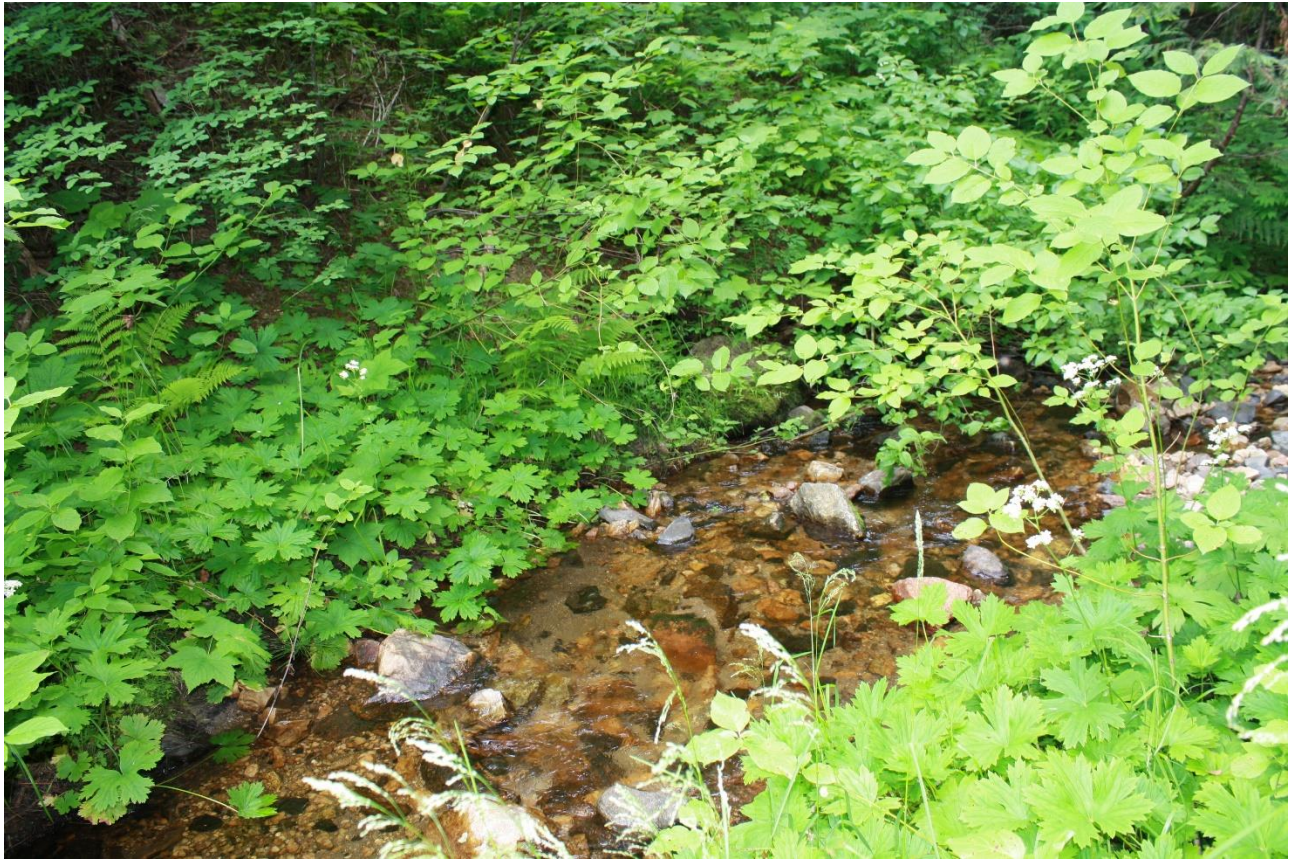
Photo 31 Reach 6: Pete King showing heavy vegetation on stream banks for stability and shade. Channel stability and resiliency to high flow events is high.

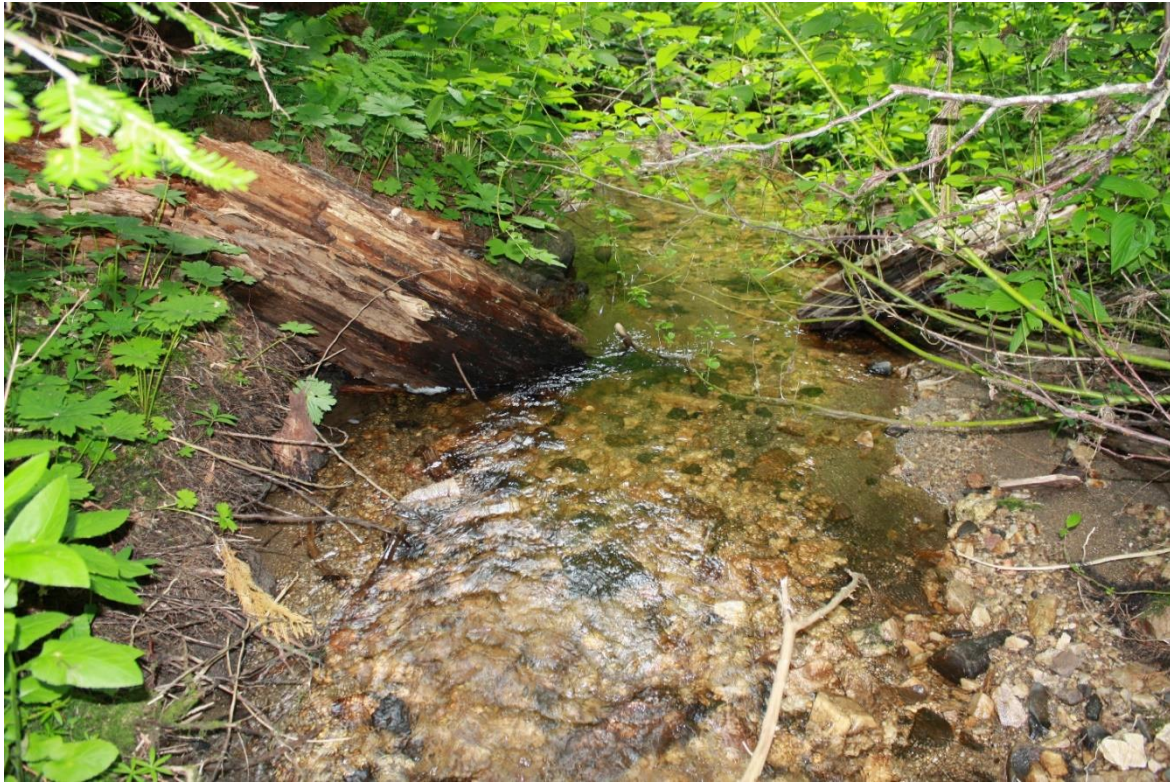
Photo 32 Reach 6: Pete King showing heavy vegetation on stream banks for stability and shade. Channel stability and resiliency to high flow events is high.

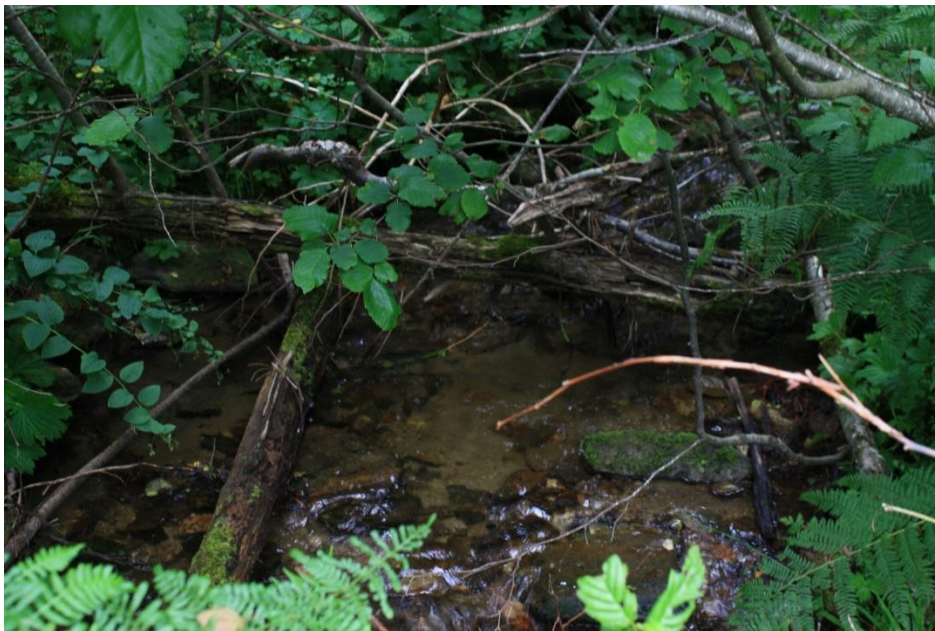
Photo 33 Reach 6: Pete King showing heavy vegetation on stream banks for stability and shade. Channel stability and resiliency to high flow events is high.

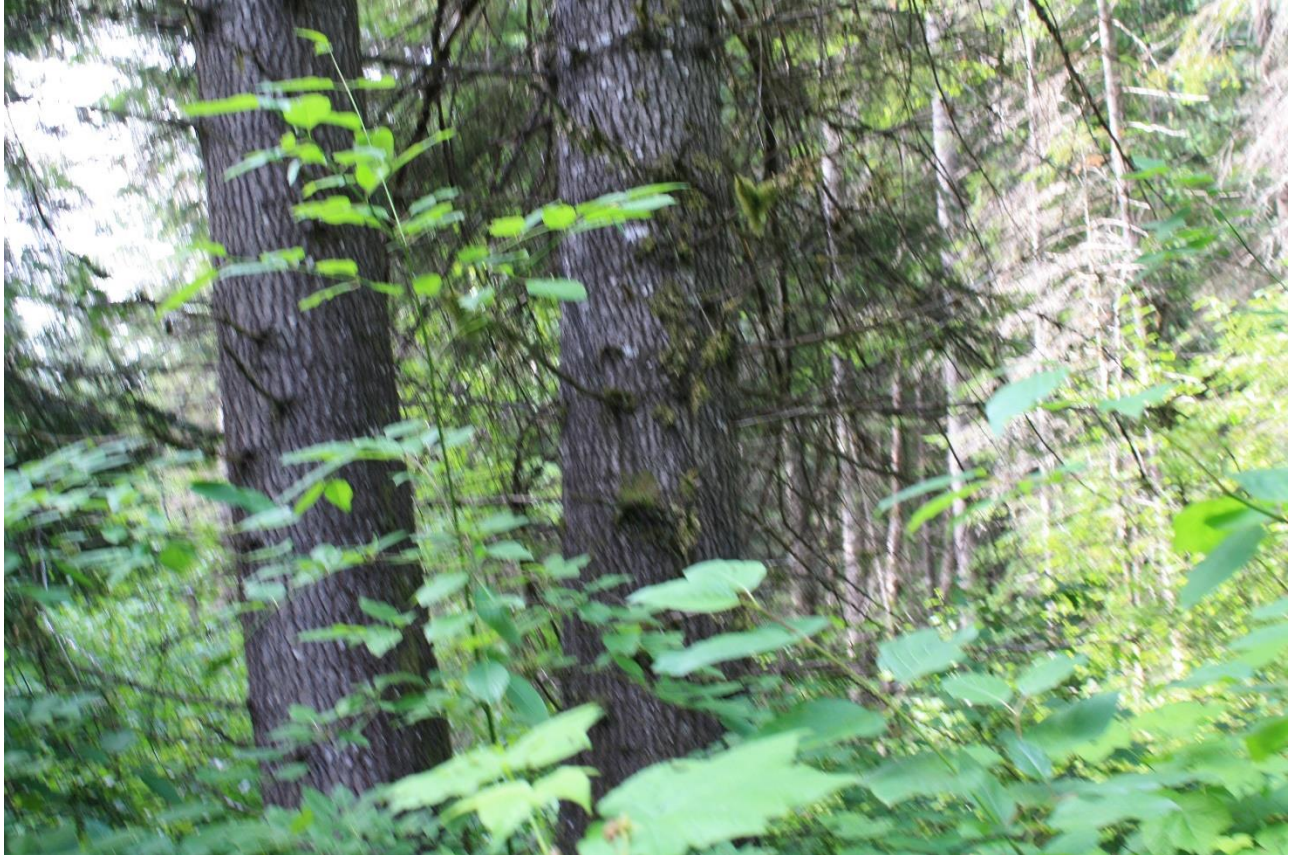
Photo 34 Reach 6: Pete King showing heavy vegetation on stream banks for stability and shade. High level of riparian LWD equipment with multi age class conifers.
